**SITE SUMMARY REPORT**  
**Old Charlotte Landfill/Vanguard Center**  
**NONCD 0001065**  
**Mecklenburg County**

Senate Bill 1492  
State of North Carolina  
State Contract N06009S  
Schnabel Project No. 06210002.30

July 21, 2010  
Revised September 20, 2010

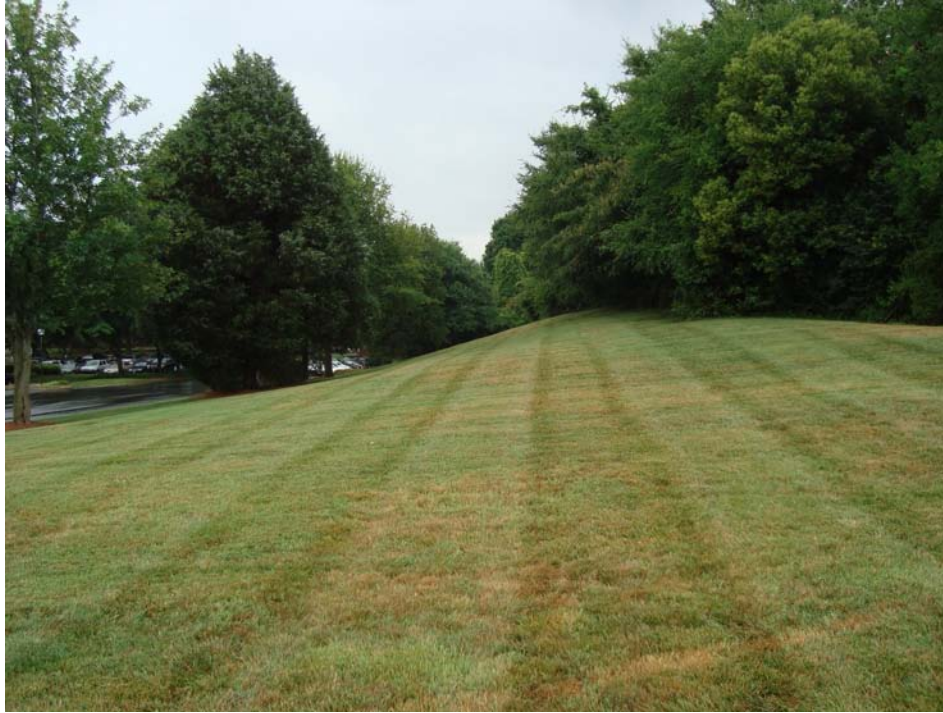
<p><b>PHOTOGRAPH No.: 1</b></p> <p><b>Photo Taken: 06-30-10</b></p>
<p>LOCATION:</p>
<p>Site and Disposal Area entrance south of Seventy- Seven Center Drive.</p>
<p>COMMENTS:</p>
<p>Photo taken facing toward the south along the eastern perimeter of the Disposal Area.</p>

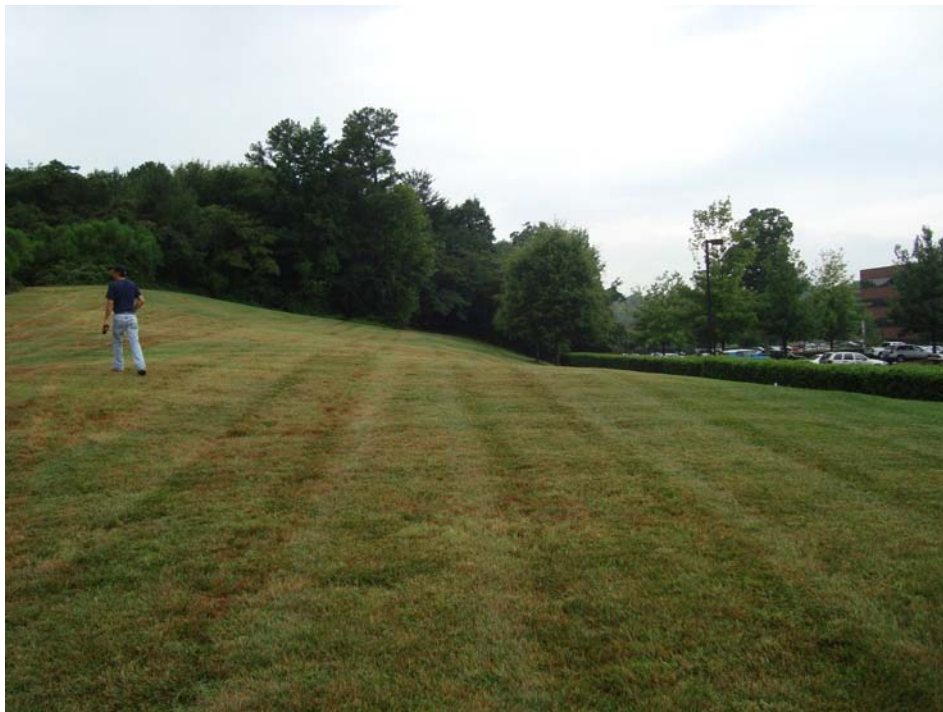
<p><b>PHOTOGRAPH No.: 2</b></p> <p><b>Photo Taken: 06-30-10</b></p>
<p>LOCATION:</p>
<p>Site and Disposal Area entrance south of Seventy- Seven Center Drive.</p>
<p>COMMENTS:</p>
<p>Photo taken facing toward the west along the northern perimeter of the Disposal Area.</p>

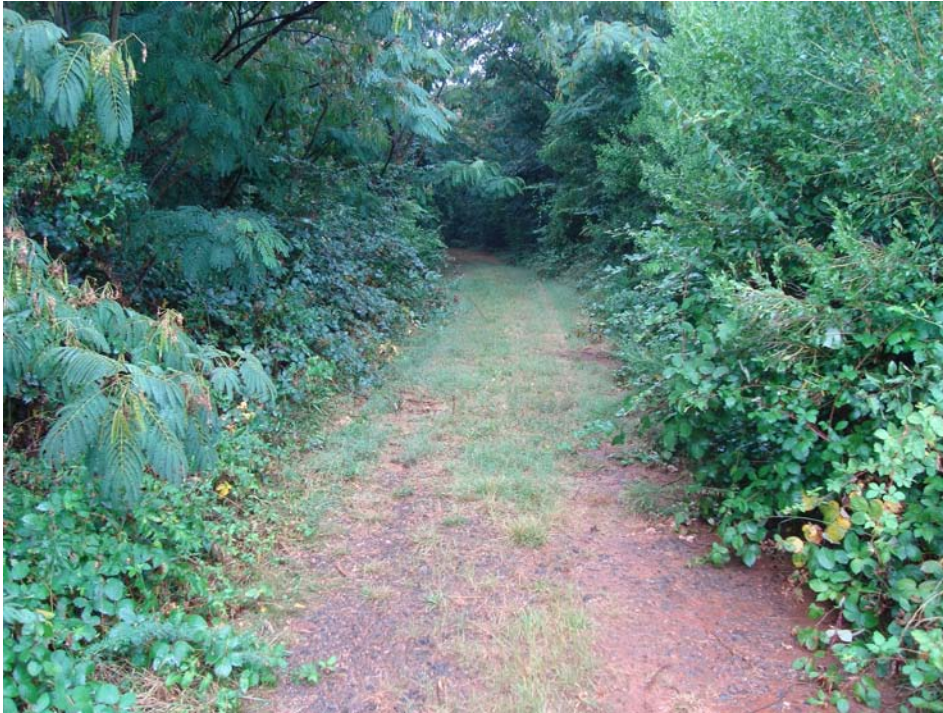
<b>PHOTOGRAPH No.: 3</b> <b>Photo Taken: 06-30-10</b>
<b>LOCATION:</b> Northern part of Disposal Area.
<b>COMMENTS:</b> Access road which leads to a billboard located on the west central part of the Disposal Area.

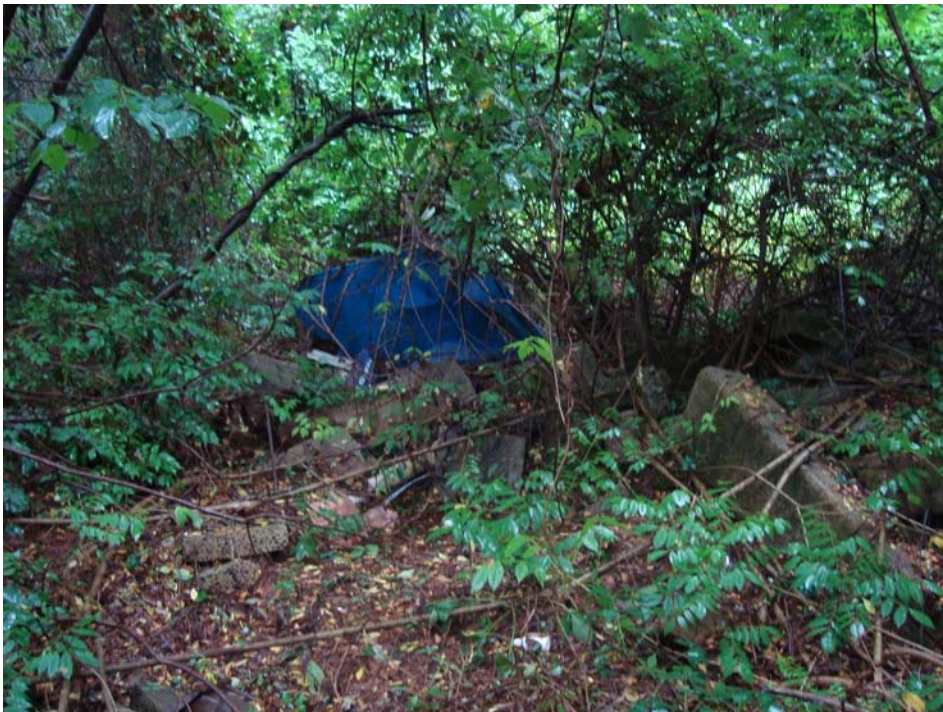
<b>PHOTOGRAPH No.: 4</b> <b>Photo Taken: 06-30-10</b>
<b>LOCATION:</b> Northern portion of Disposal Area.
<b>COMMENTS:</b> Concrete blocks and blue plastic tarp.

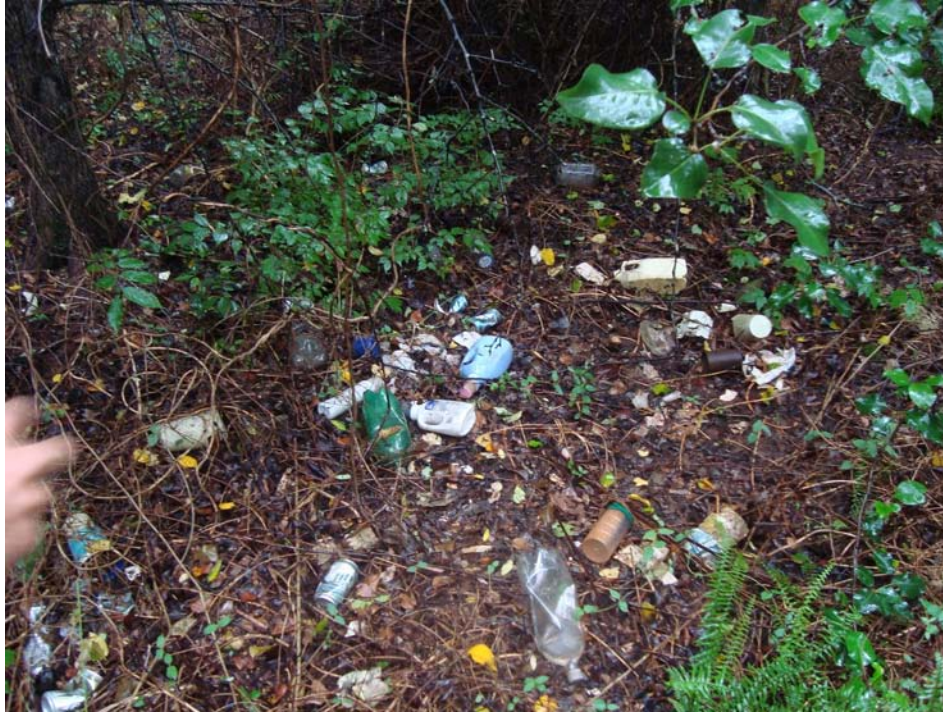
<b>PHOTOGRAPH No.: 5</b>
<b>Photo Taken: 06-30-10</b>
LOCATION:
Northern part of Disposal Area.
COMMENTS:
Recent trash disposal consisting of plastic bottles, cans, and glass bottles.

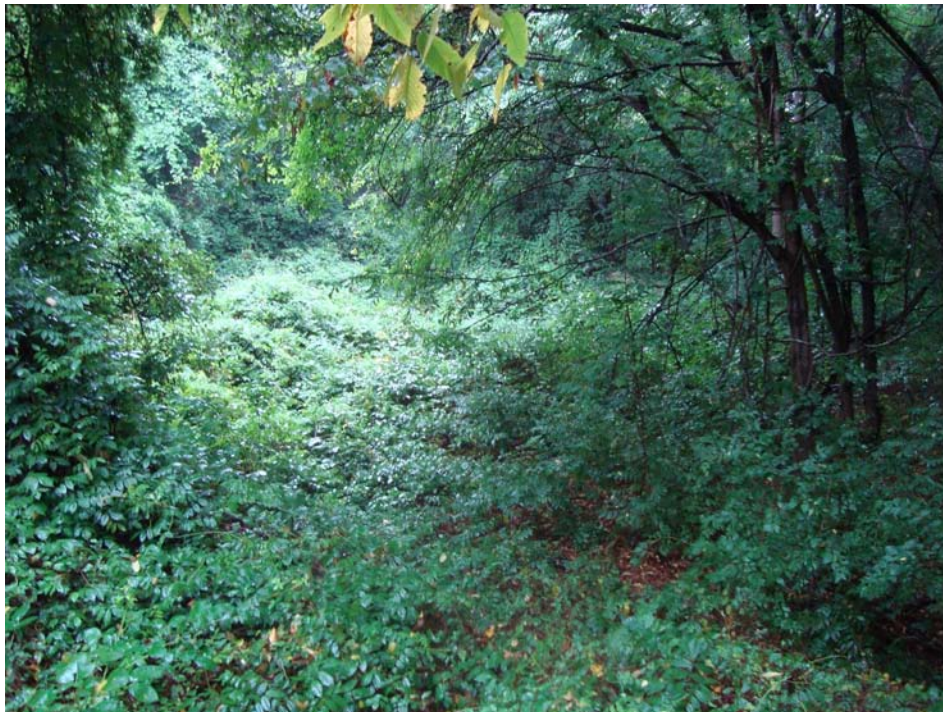
<b>PHOTOGRAPH No.: 6</b>
<b>Photo Taken: 06-30-10</b>
LOCATION:
Northern portion of Disposal Area.
COMMENTS:
Photo taken facing toward the east. Dense vines and shrub growth in Disposal Area.

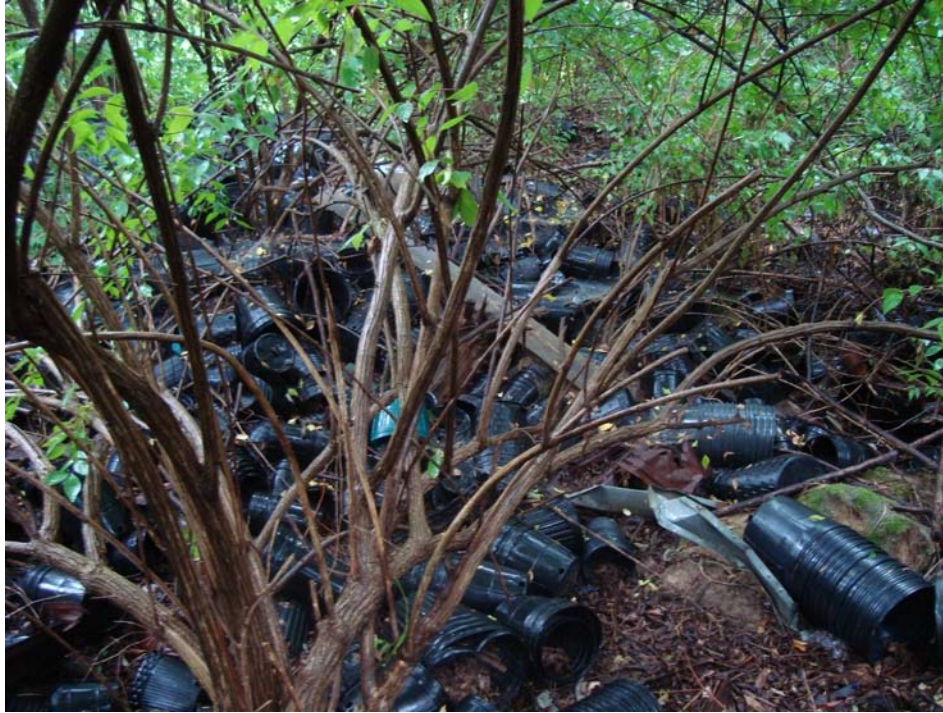
<b>PHOTOGRAPH No.: 7</b>
<b>Photo Taken: 06-30-10</b>
LOCATION:
North central part of Disposal Area.
COMMENTS:
Black plastic plant pots on landfill slope. Landfill slope approximately 5 feet high.

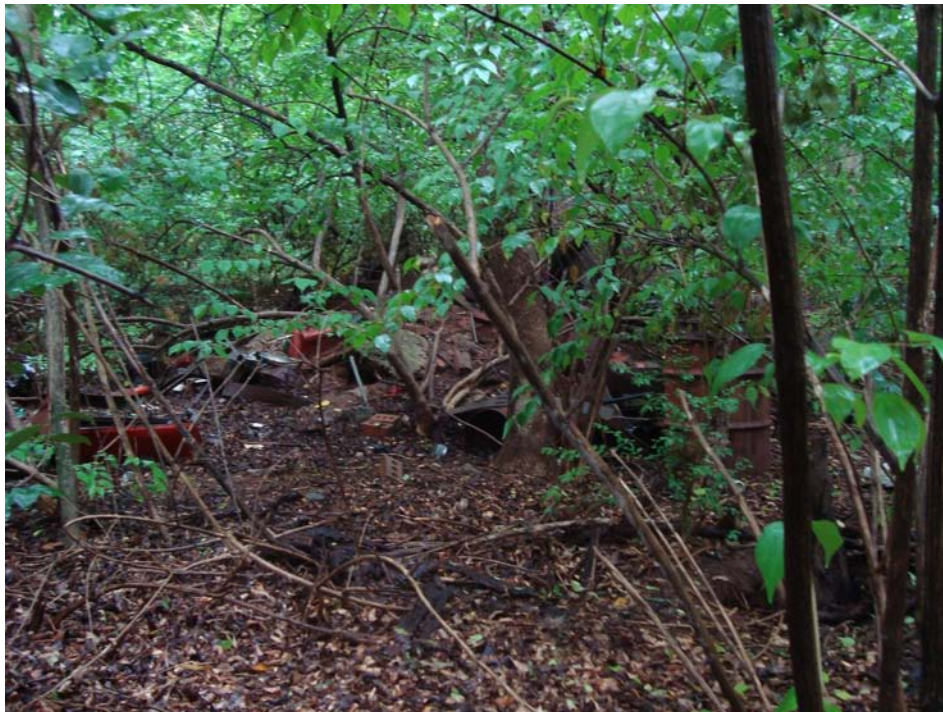
<b>PHOTOGRAPH No.: 8</b>
<b>Photo Taken: 06-30-10</b>
LOCATION:
North central part of Disposal Area.
COMMENTS:
Scrap metal, rusted 55-gallon drums, brick, broken concrete, and plastic materials.

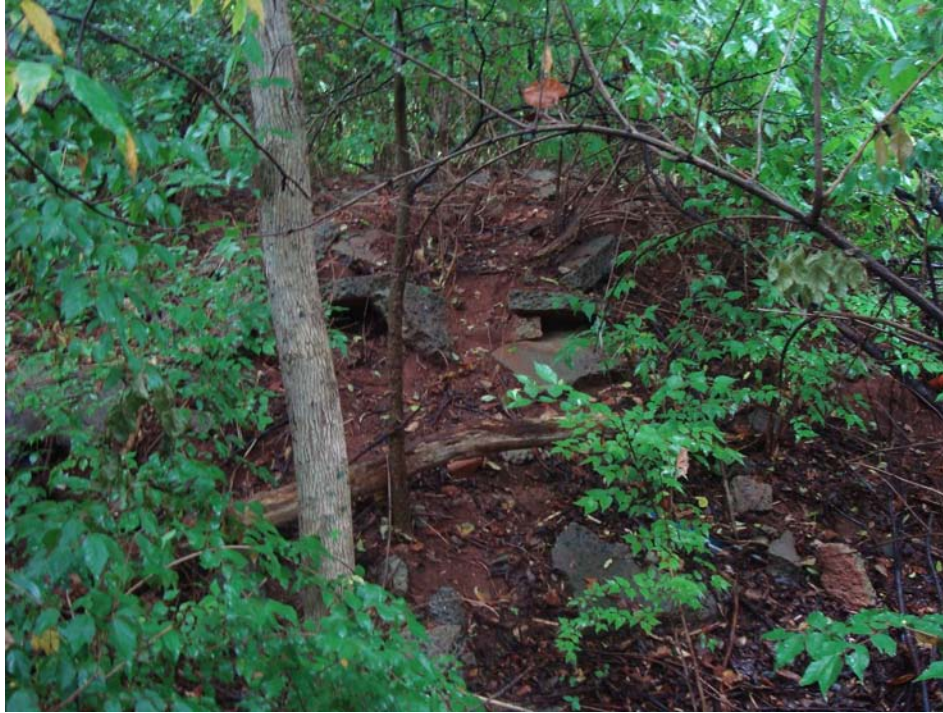
<b>PHOTOGRAPH No.: 9</b>
<b>Photo Taken: 06-30-10</b>
LOCATION:
North central part of Disposal Area.
COMMENTS:
Broken pieces of concrete. Holes visible in the landfill slope between the pieces of concrete. Landfill slope approximately 5 feet high.

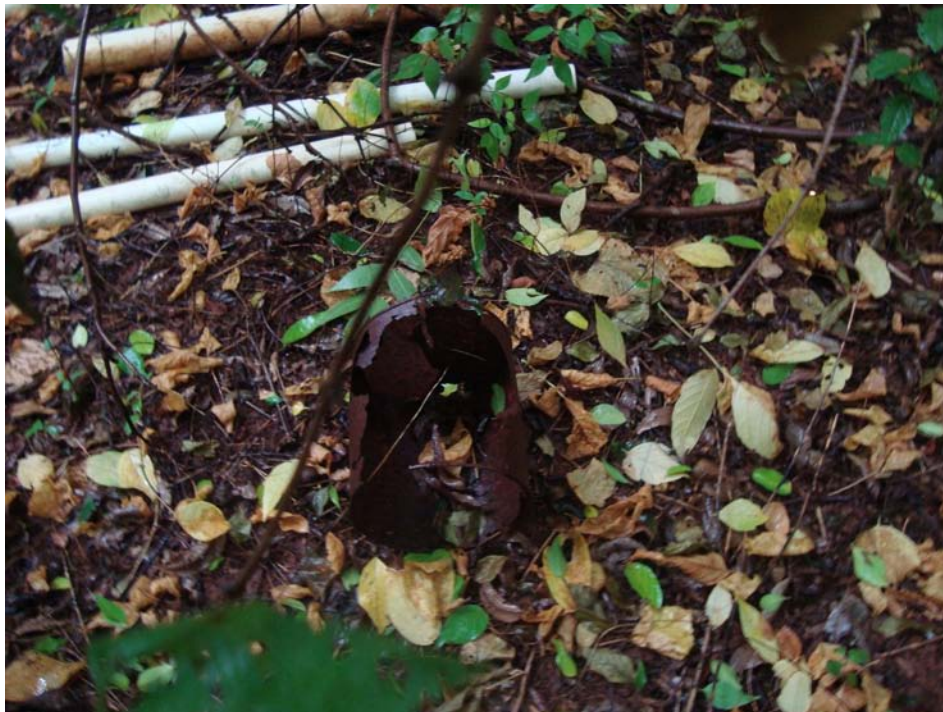
<b>PHOTOGRAPH No.: 10</b>
<b>Photo Taken: 06-30-10</b>
LOCATION:
North central part of Disposal Area.
COMMENTS:
PVC pipes and rusted paint can.

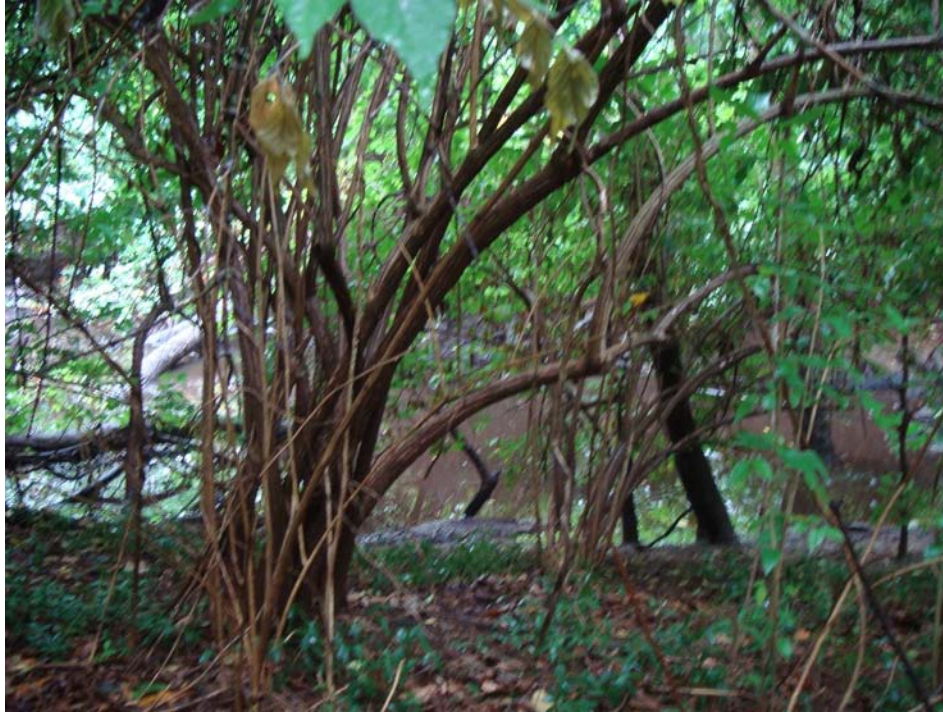
Standing water was observed on the northwestern part of the Disposal Area. The standing water was approximately 20 feet in diameter and the water was cloudy. Disposal material was not observed in the water at the time of the site visit.

<b>PHOTOGRAPH No.: 11</b>
<b>Photo Taken: 06-30-10</b>
LOCATION:
Northwestern part of Disposal Area.
COMMENTS:
Standing water approximately 20 feet by 20 feet. Water was cloudy at the time of the site visit.

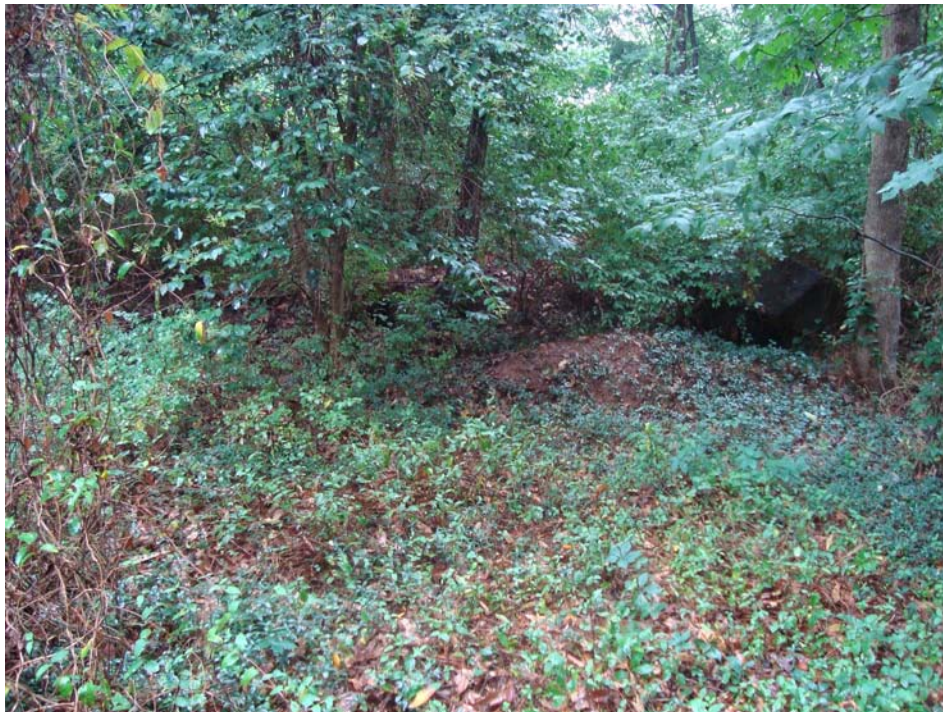
<b>PHOTOGRAPH No.: 12</b>
<b>Photo Taken: 06-30-10</b>
LOCATION:
Northwestern part of Disposal Area.
COMMENTS:
Hummocky topography and dense vine covers the ground surface.

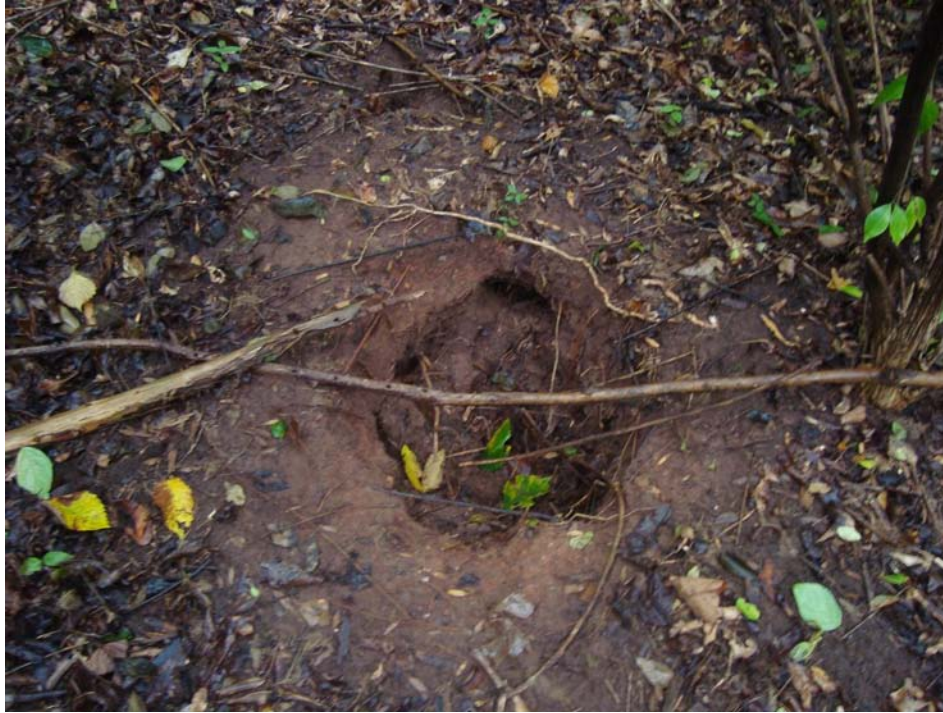
An erosional gully approximately two to four inches wide and one foot deep (Photo 14) and a hole about two feet in diameter and one foot deep (Photo 13) were observed on the northwestern part of the Disposal Area. Holes and depressions were also observed on the north central part of the Disposal Area (Photo 9) on a landfill slope. The landfill slope located through the center of the Disposal Area was approximately five feet high and disposal material was observed protruding from the slope at the time of the site visit (Photos 7 and 9). Hummocky topography (Photo 12), berms, and soil piles were observed in the northern and eastern part of the Disposal Area.

<b>PHOTOGRAPH No.: 13</b>
<b>Photo Taken: 06-30-10</b>
LOCATION:
Northwestern part of Disposal Area.
COMMENTS:
Hole approximately two feet by two feet and 1 foot deep.

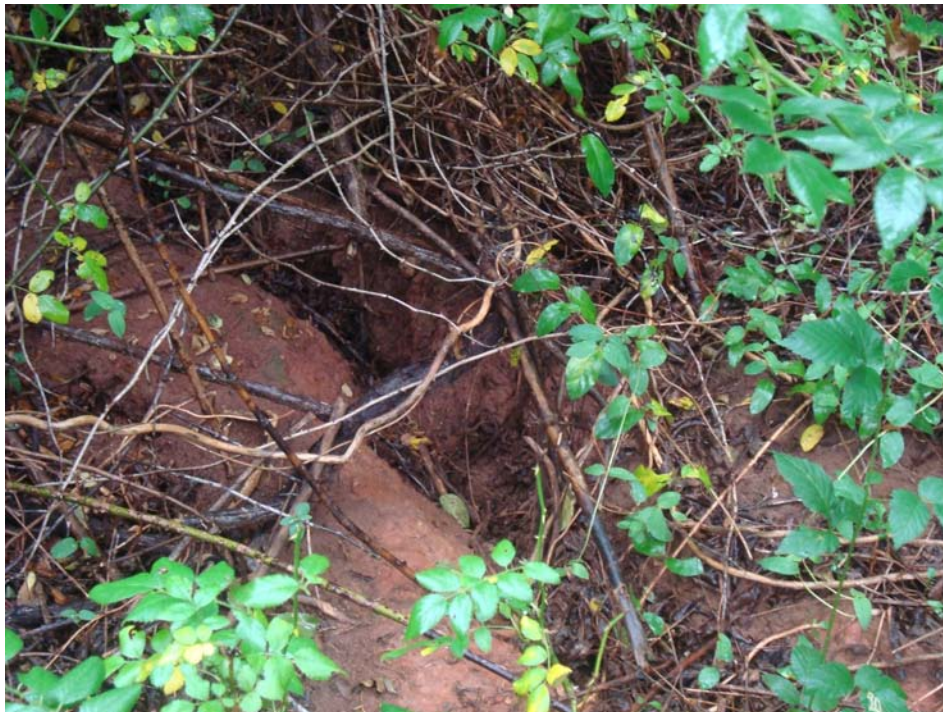
<b>PHOTOGRAPH No.: 14</b>
<b>Photo Taken: 06-30-10</b>
LOCATION:
Northwestern part of Disposal Area.
COMMENTS:
Small erosional gully approximately two to four inches wide and one foot deep.

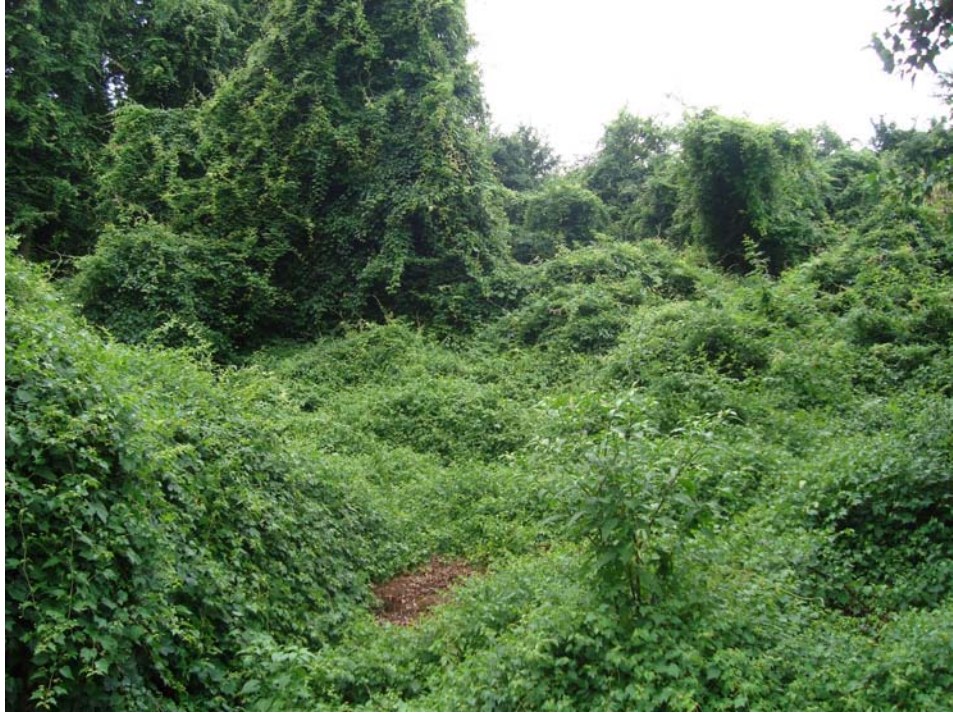
<b>PHOTOGRAPH No.: 15</b>
<b>Photo Taken: 06-30-10</b>
LOCATION:
Southern part of site along eastern boundary of Disposal Area.
COMMENTS:
Dense kudzu and deciduous trees.

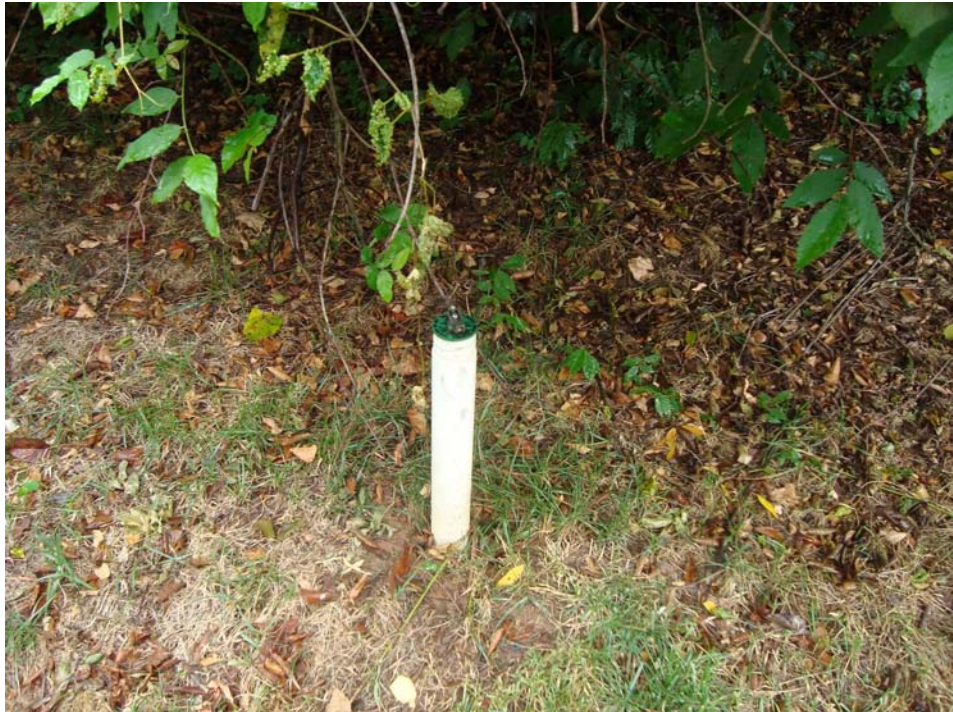
<b>PHOTOGRAPH No.: 16</b>
<b>Photo Taken: 06-30-10</b>
LOCATION:
Along eastern boundary of Disposal Area.
COMMENTS:
Piezometer with unlocked well cap.

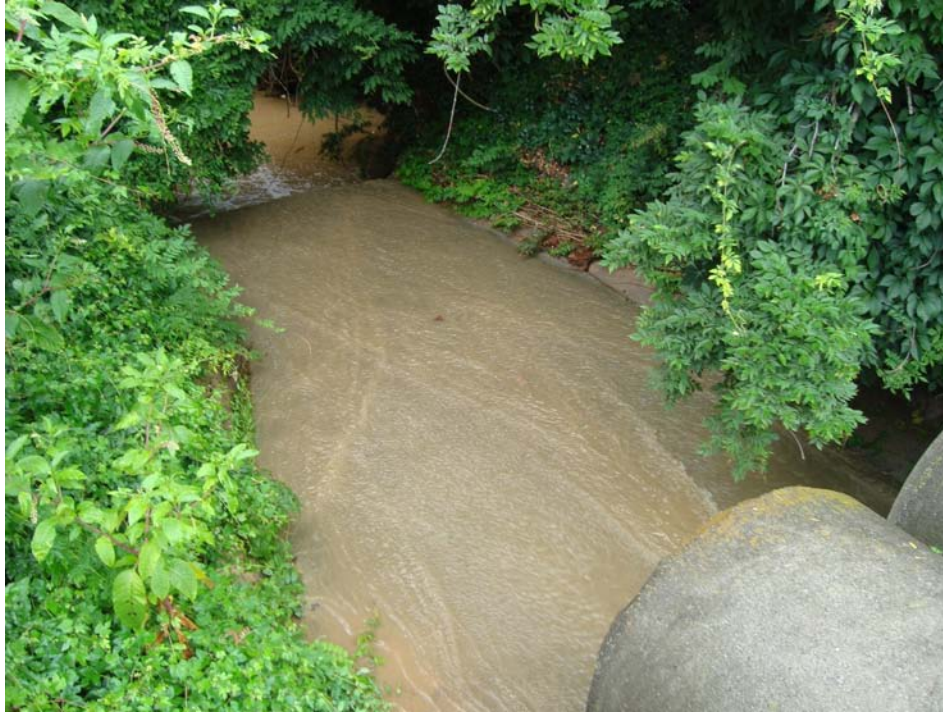
<b>PHOTOGRAPH No.: 17</b> <b>Photo Taken: 06-30-10</b>
<b>LOCATION:</b> Southern part of Disposal Area.
<b>COMMENTS:</b> Unnamed intermittent stream approximately 10 feet wide with cloudy water at the time of the site visit.

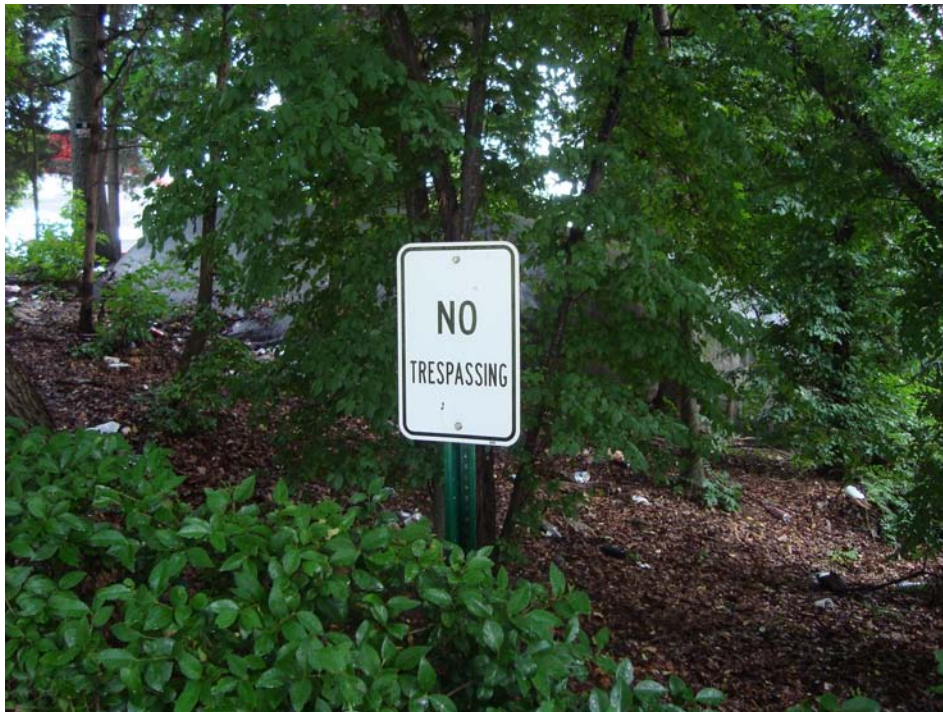
<b>PHOTOGRAPH No.: 18</b> <b>Photo Taken: 06-30-10</b>
<b>LOCATION:</b> Southern part of Disposal Area.
<b>COMMENTS:</b> "No Trespassing" sign and recent dumping of trash on the Disposal Area.
